FI Missouri Remediation Trust

Re: Administrative Settlement and Order on Consent for Treatability Study ("TS"), Docket No. CERCLA -07-2016-0004 (the "Settlement")
FI Missouri Remediation Trust Property, Joplin, Missouri

Photographic Documentation

RE: Construction Summary Report
Lateral Drain System
Former Farmland Industries Site
Joplin, Missouri

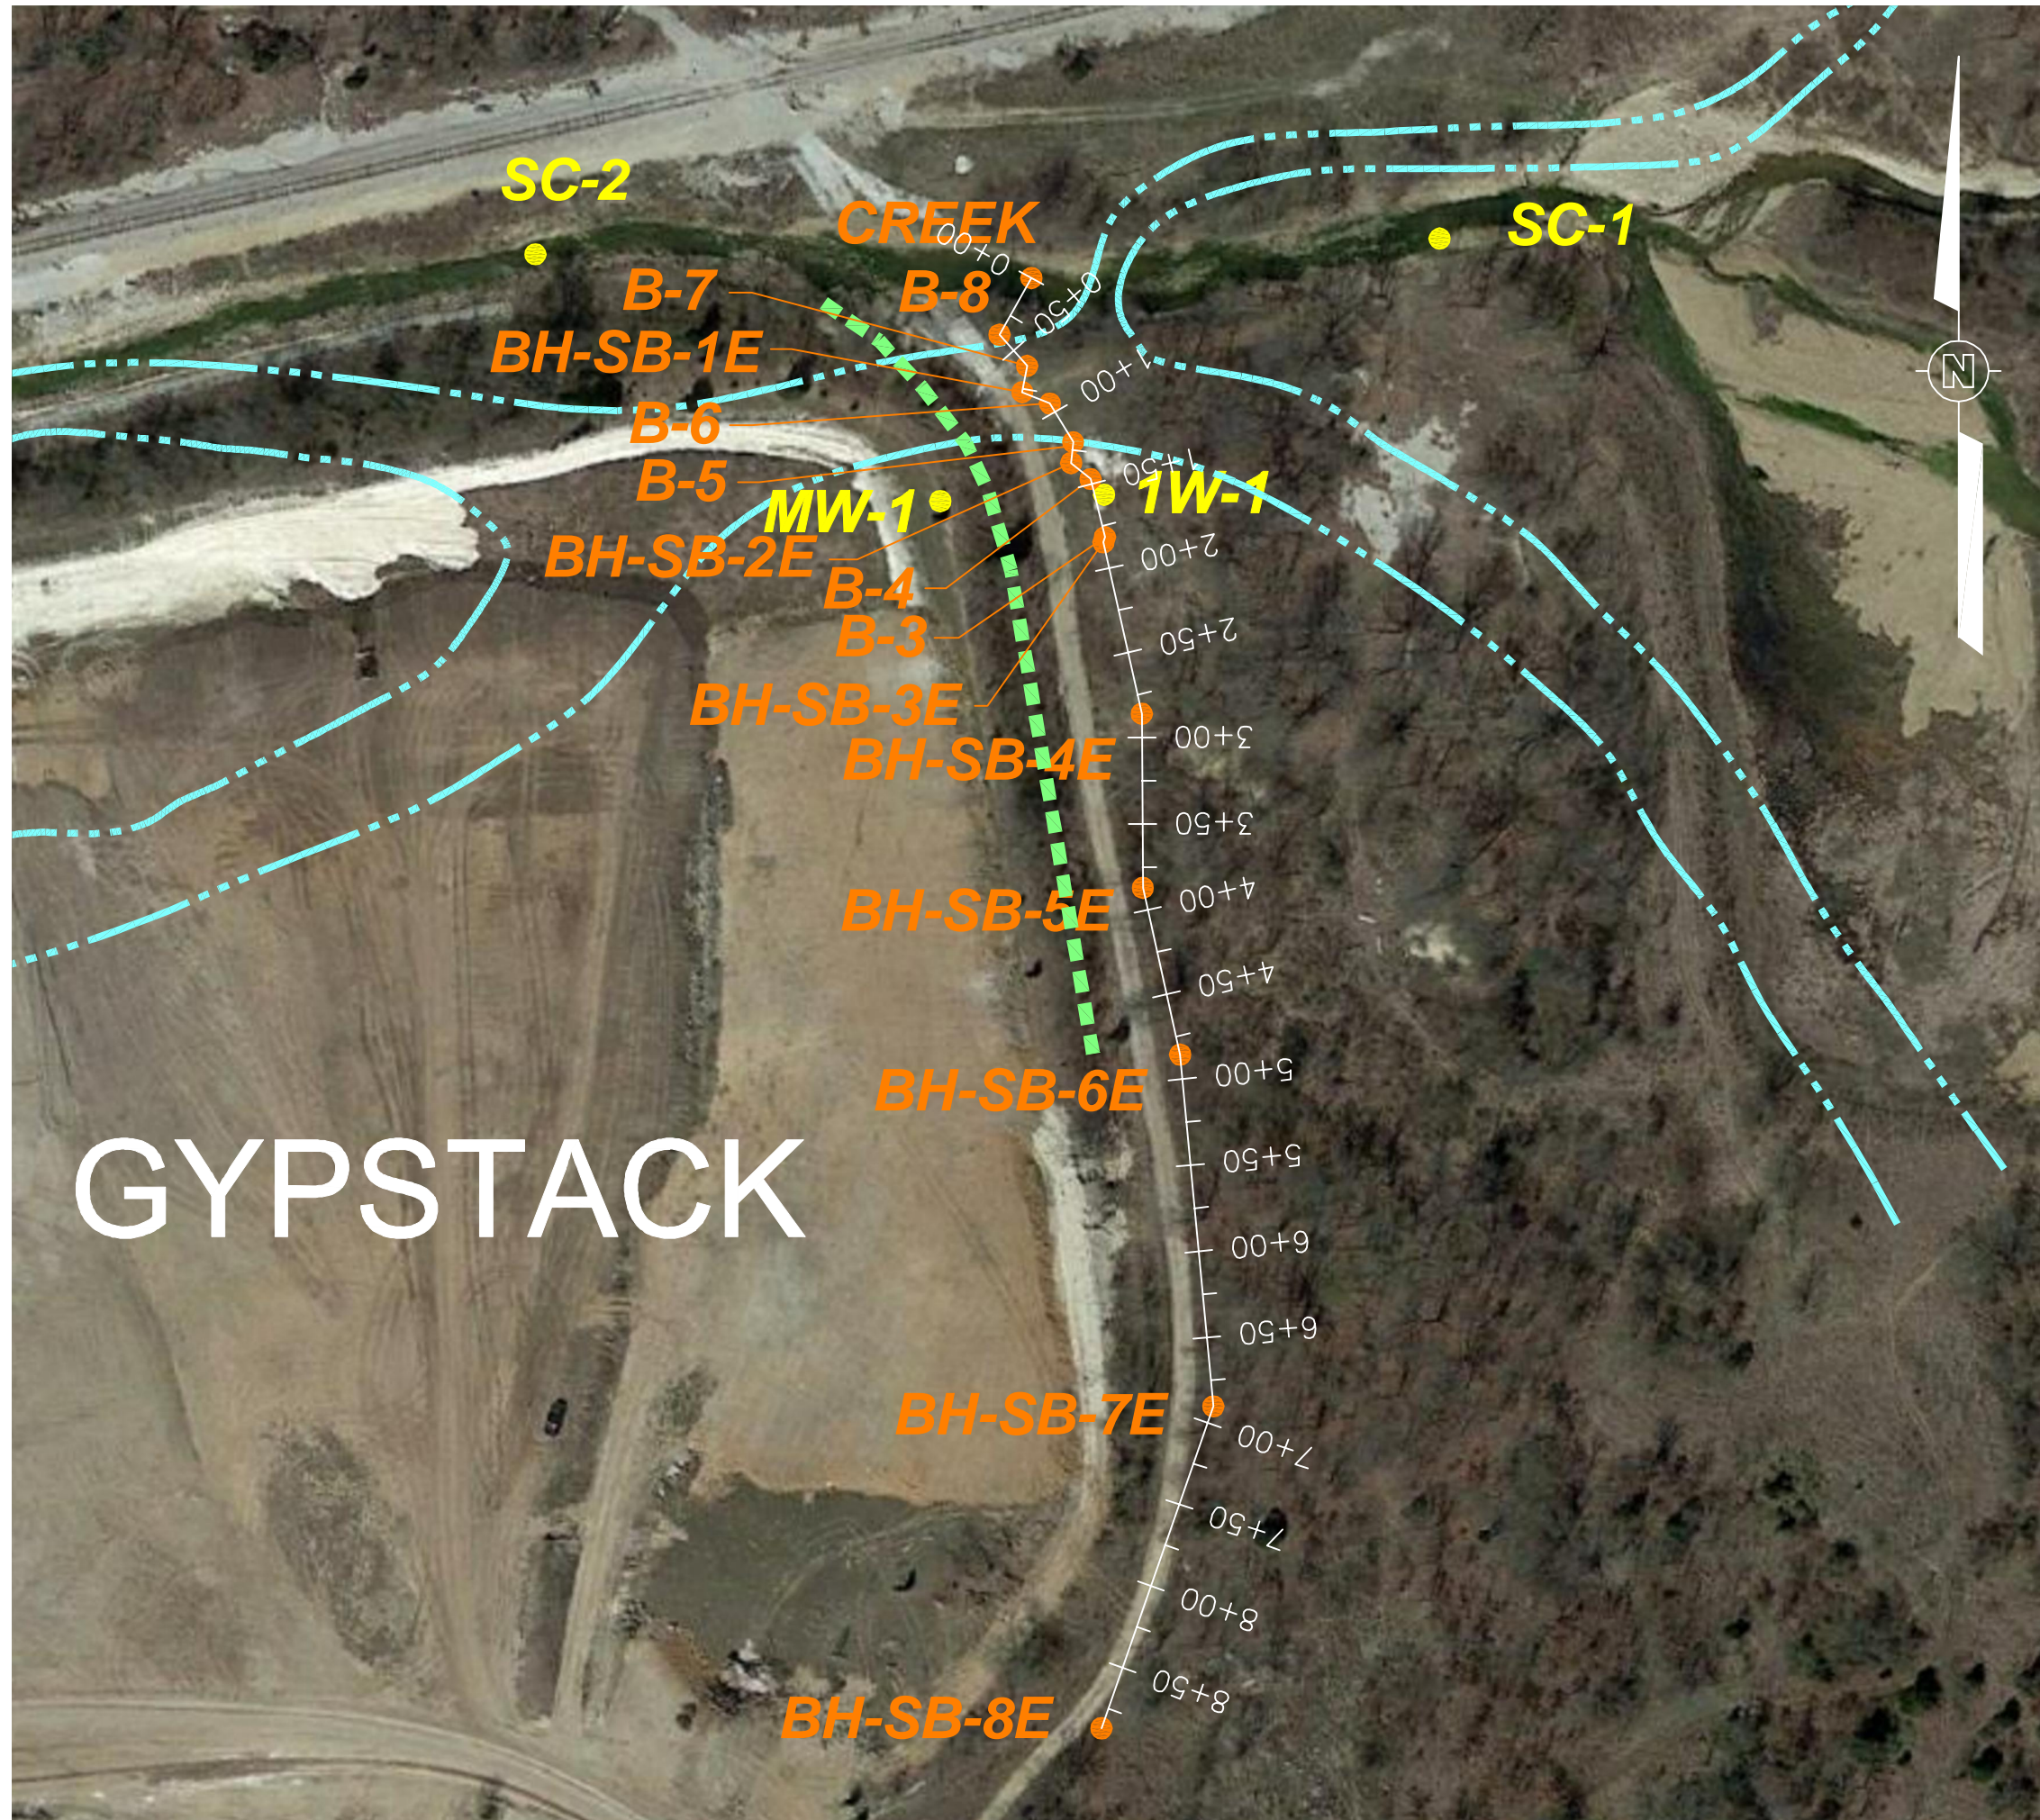
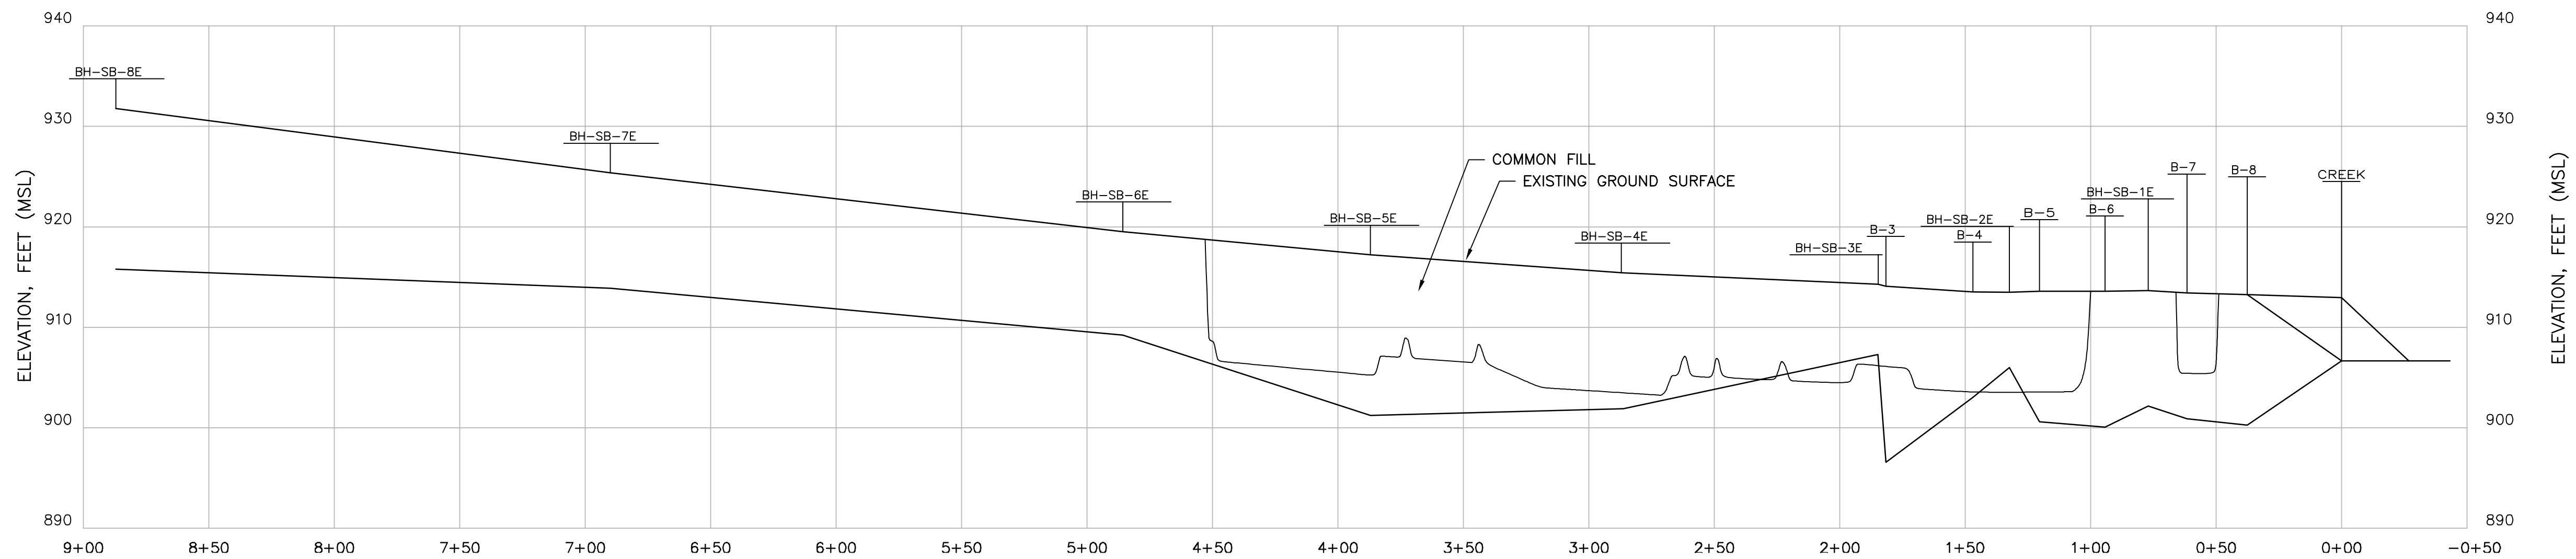
FI MISSOURI REMEDIATION TRUST
FORMER FARMLAND INDUSTRIES
**APPROXIMATE TRENCH LOCATION
LATERAL DRAIN SYSTEM**
JOPLIN, MISSOURI

High inflows of groundwater were observed at STA 3+53 and 3+87, presumably the extents of the former Short Creek channel, and between STA 2+60 to 2+80 along a limestone shelf. The pH of the water within the trench varied, ranging from 5.49 (2+60) to 6.04 (3+15) and 6.78 to 7.00 (4+04). The low pH of the water observed in the trench suggest that leachate from the adjacent gypstack is entering the trench.

In flows at STA 3+53 and 3+87 were estimated at over 80 gpm. The design included a grout seal at the base of the LLDPE liner to minimize under flow from the gypstack side of the trench, but a competent seal could not be guaranteed under these inflow conditions. It is assumed that the high hydraulic head observed in the trench was the result of the infiltration of surface water in the east extent of the gypstack following periods of high precipitation. The site received heavy precipitation preceding and during the trench construction activities to include; 1.45 inches from April 2-5, 1.03 inches on April 16, 2.47 inches from April 20-22, and 1.14 inches from April 26-27.

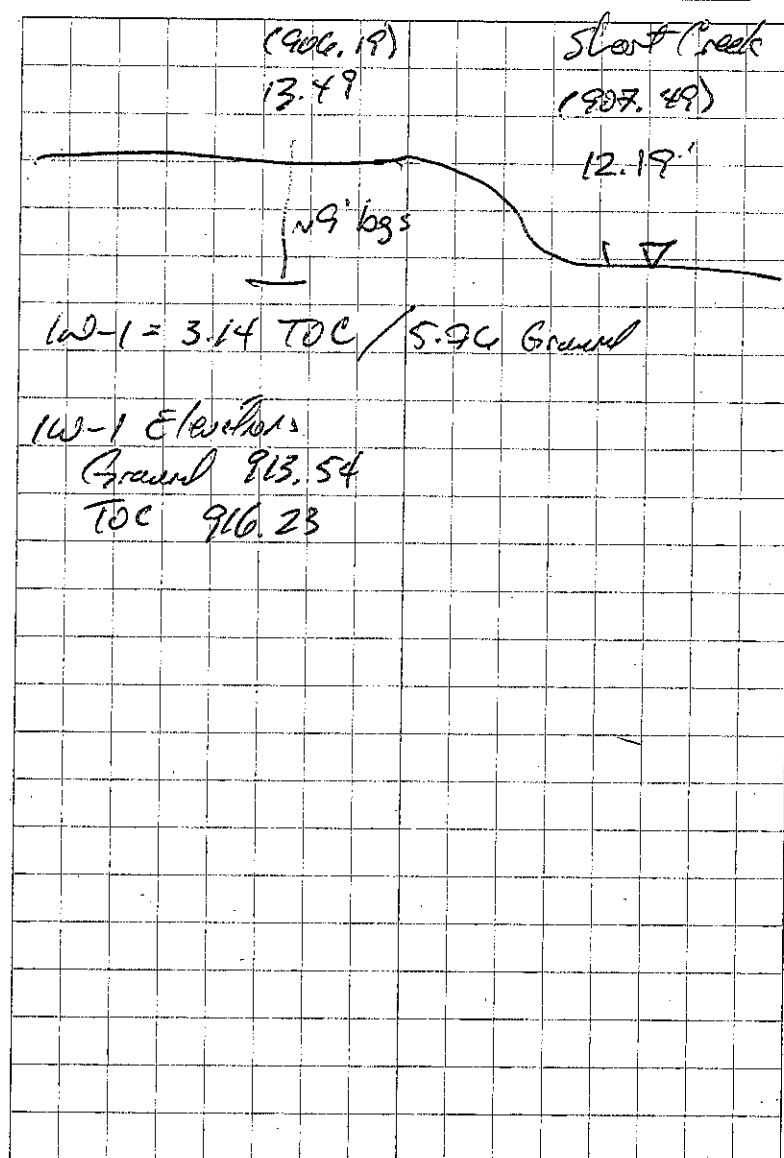
Location _____ Date 4/24/17 23
 Project / Client _____

- April 25, 2017 Tuesday
- 0650 Arrived On Site - Shag 3 cords
- 0715 Started 5 pumps 1-2" 2-3"
- 0730 Trenchgate Safety Meeting
- 5' Trench pH = 6.04
- 11' Trench pH = 6.78
- SC pH = 7.30
- 0805 6" pump on Site
- 0853 6" pump running - water level in trench
is dropping
- 0928 Resumed Excavating Trench - very hard digging
just bedrock (trench dewatered)
- 1025 CAT 304 with rock breaker on Site
- 1254 Don Van Dyke + 1 MDNR on Site
Don Van Dyke & Mark Dodson - abandon
the trench - backfill
- 21420 MDNR on Site
- 1160 Met w/ STAR Plumbing - will pick up
unused materials and check on return price
- 1700 Loaded materials for return to STAR
- 1720 began backfilling Trench S → N, running 6" pump
- 1945 Backfilled 3/4 of trench
on Site

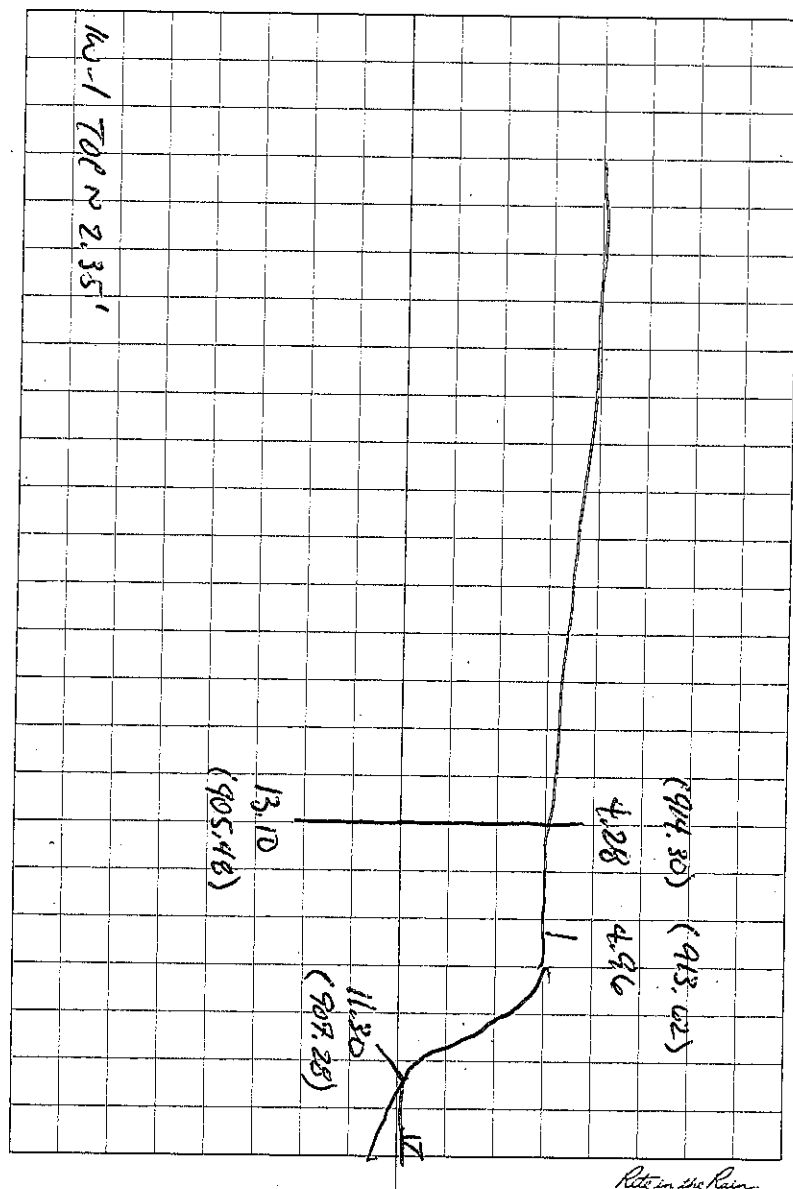
4/25/17

April 26, 2017 Wednesday
 0708 Arrived On Site - light rain, dropping
 temps. Heavy rains overnight damaged
 Gypstock hold-down structure. very wet
 0715 To gate
 0720 Resumed dewatering Trench
 1201 Completed backfill trench and
 repairing creek crossing and road
 Staged equipment for pickup
 1240 off Site - Still Raining
 Mark C. Harvey
